Oil Coated Fittings versus Penn Machine Standard Phosphate Coated Fittings

Humidity & Salt Spray Testing

Purpose: To see poorly coated areas
that are subject to rusting.

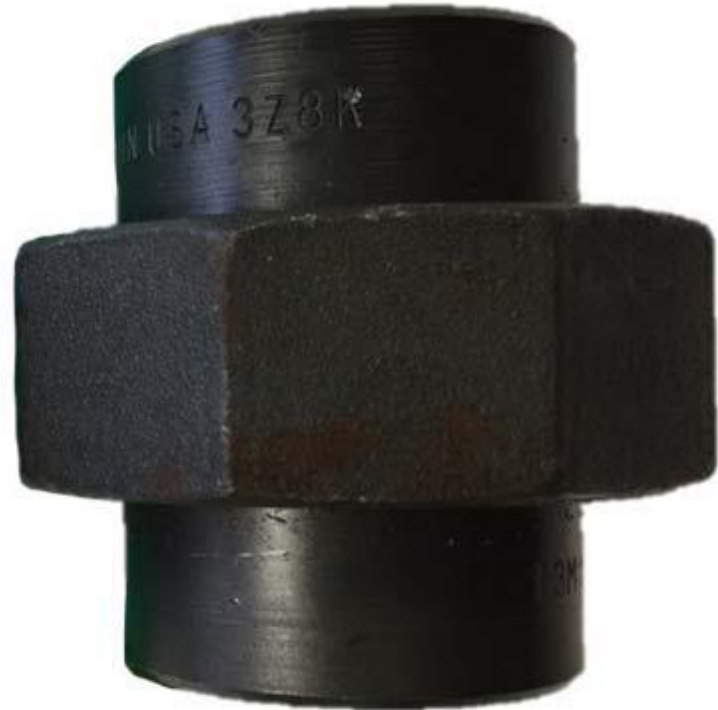
5% Red Rust
Observed on
Phosphate
Coated Fitting

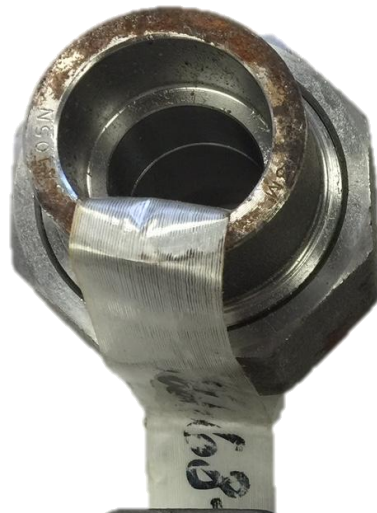
Heavy Rust
Observed on
Faces of Oil
Coated
Fittings

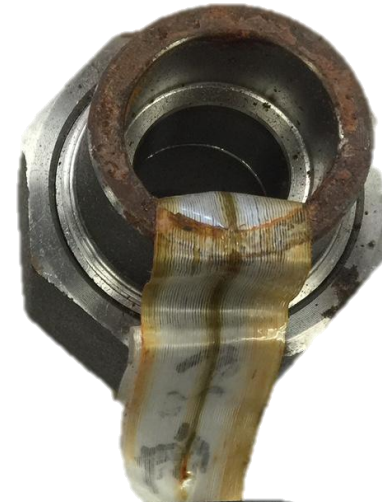
Heavy Rust
Observed on
Faces of Oil
Coated
Fittings

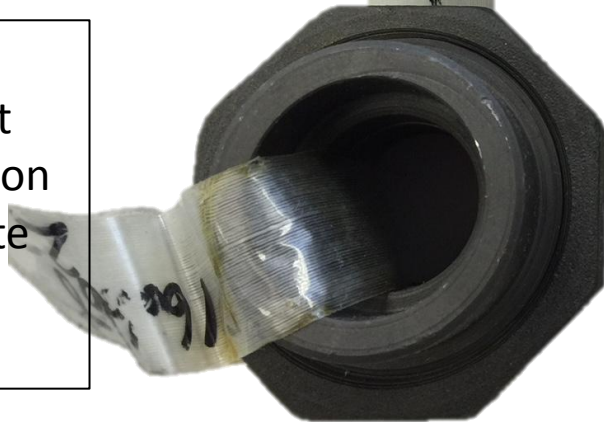
0 – 1%
Red Rust
Observed on
Phosphate
Coated
Fittings

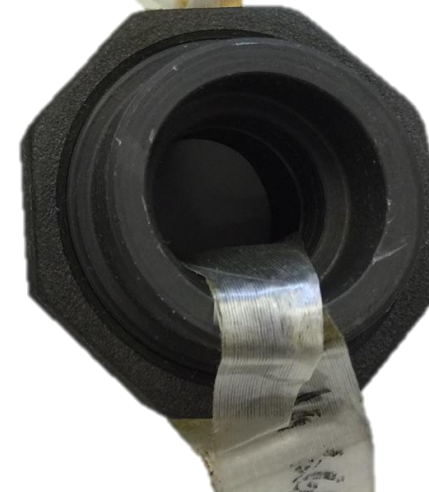
0 – 1%
Red Rust
Observed on
Phosphate
Coated
Fittings

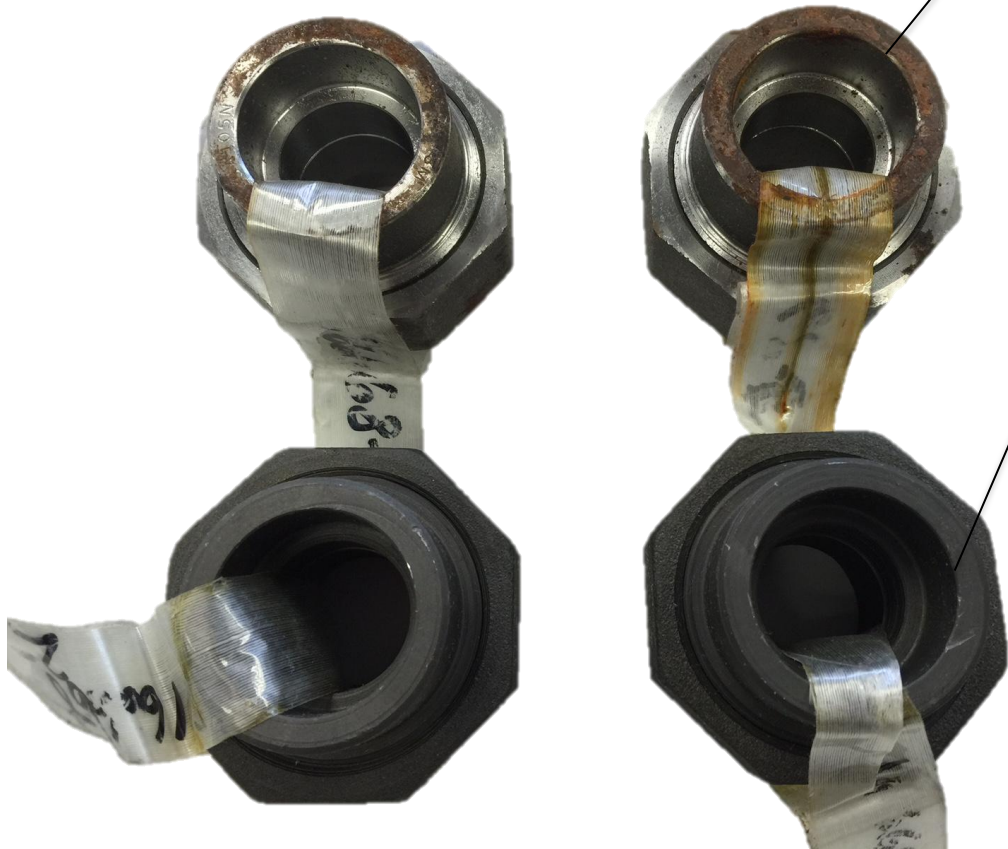
Oil Coated Vs. Phosphate Coated Fittings

Rust Noticed on Face of fittings as well as other areas of fittings that were Oil Coated, It is evident that the oil is not systematically applied, leaving areas un-protected.

On Phosphate Coated Fitting the coating is uniformly applied. The fittings are evenly coated protecting all surface areas of the fittings.

- Oil Coating does not evenly coat all surfaces of the fitting.
- Oil Coating easily comes off, leaving fitting unprotected.
- Oil Coating application is not uniform and therefore is inconsistent in its application.
- Other Coatings such as phosphate are uniformly applied to all surfaces both internal and external.
- Testing and Pictures show the inadequate protection of all surfaces of sampled fittings using Oil Coating versus Phosphate Coating.
